# **WEST PATRAIKOS LEASE AREA ENVIRONMENTAL REPORT 2016**

## WEST PATRAIKOS LEASE AREA – ENVIRONMENTAL REPORT 2016

### HSE Policies & System, Environmental Studies and Implementation

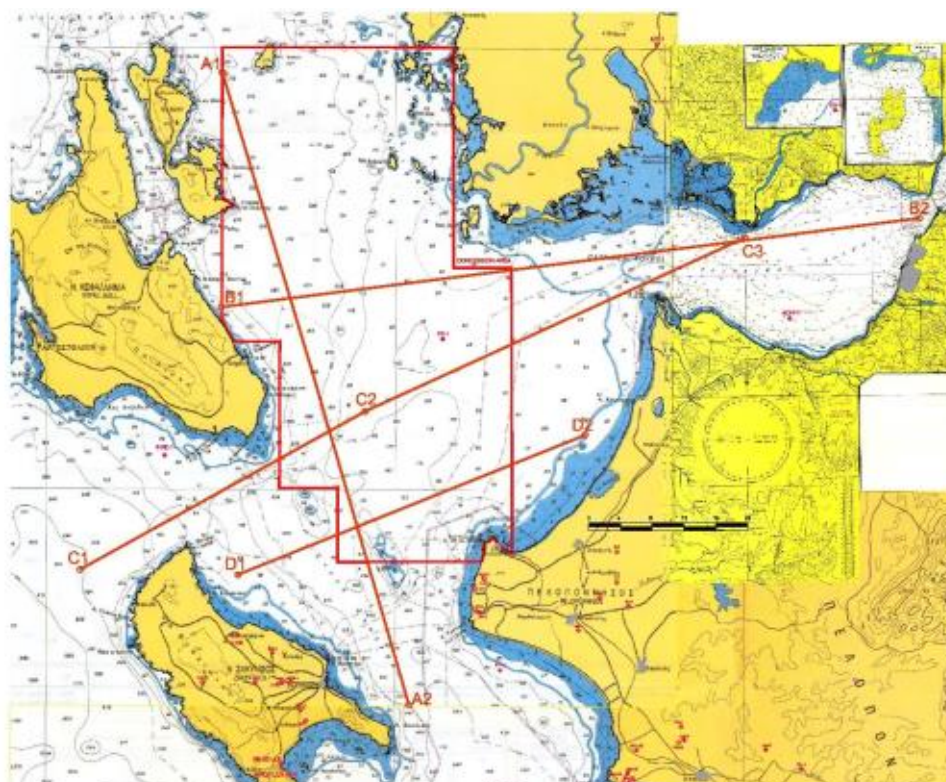
Figure 2 Contract Area and 2D Lines (HELPE, 2015)

The Contract Area with the 2D Lines are shown in the following Figure 2. Length and coordinates of the 2D Lines are reported in Table 2.

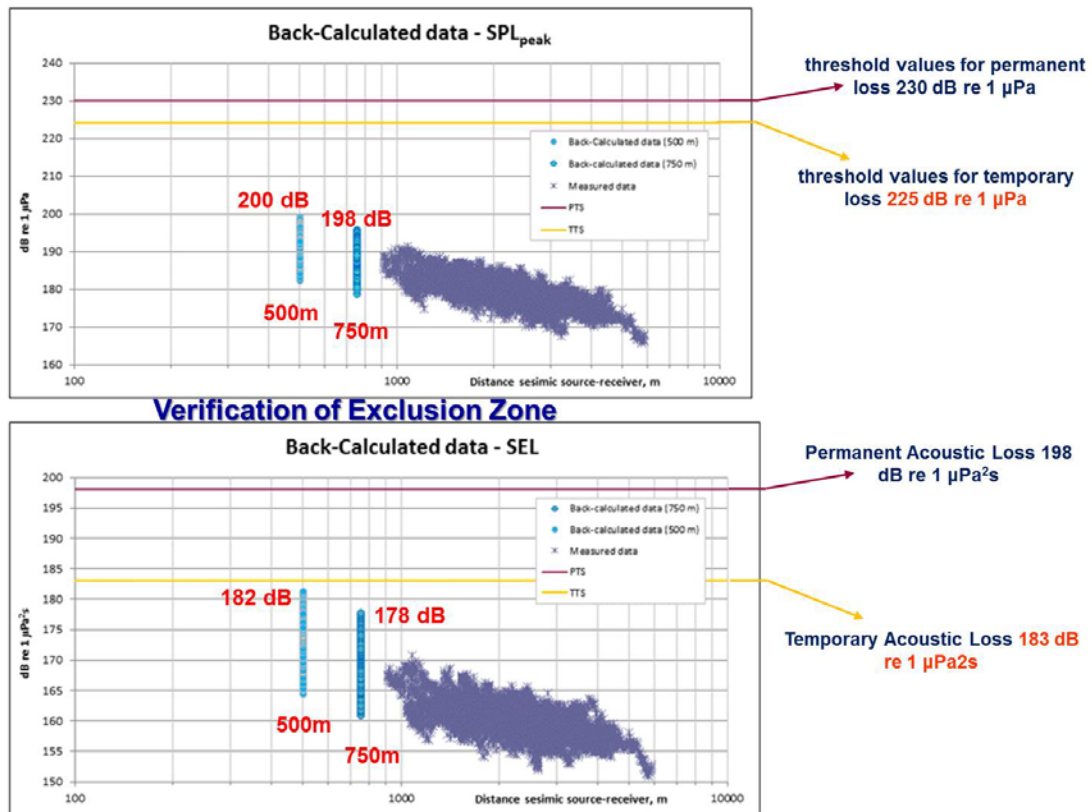
Figure 9 Verification of Exclusion Zone

The aim of the acoustic survey at that stage was to assess the sound pressure level of the noise induced by the air-gun seismic source to the predefined sampling locations. During the seismic noise monitoring, a total of 30 deployments have been realized. Additionally, field measurement of noise levels around the seismic source (air-guns) were carried out during the acquisition activities in order to record and study the seismic noise attenuation levels and validate the specified mitigation zone. None of the measured values exceeded the threshold values defined for permanent loss (PTS) and temporary loss (TTS) of auditory sensitivity for marine mammals (Southall et al., 2007) at any distance (Figure 9).

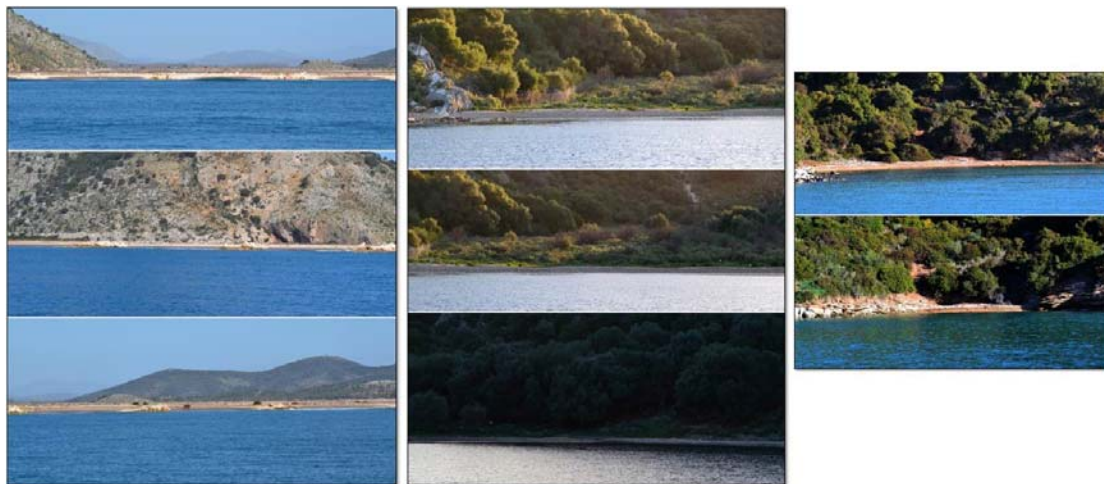
Figure 10 Coastal Zone Inspection

A visual inspection for marine mammals' presence was carried out. The vessel departed from Astakos port heading to the survey area. A coastline of 35 nm was visual inspected and twenty predefined areas were closely approached. The areas with the highest likelihood of marine mammal presence were selected based on the coastal morphology and sea currents directivity. The visual inspection of the coastal zone environment did not show any mammal.

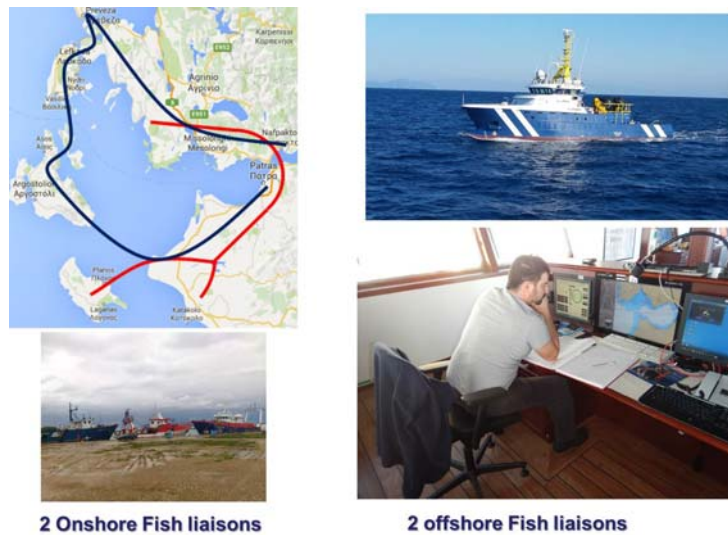
Figure 11 Fish Liaisons Officers Effort

Great effort was taken by the FLO team to minimize disturbance to fishing activities within the affected area by being on watch (between them) 24/7 throughout operations (Figure 11). The team would have to act promptly to retrieve all kinds of FADs - fishing gear, buoys and debris from the water and advise local fisheries and seismic vessel crew on potential safety hazards. When necessary, the FLO would request that the captains of certain fishing boats or indeed the streamer vessel adjust their course to avoid collision (Figure 12).
